## **FACE INVESTIGATION**

**SUBJECT: Part-time Logger Pinned by Tractor Wheel after Being Knocked from Operator's Seat by Falling Tree**

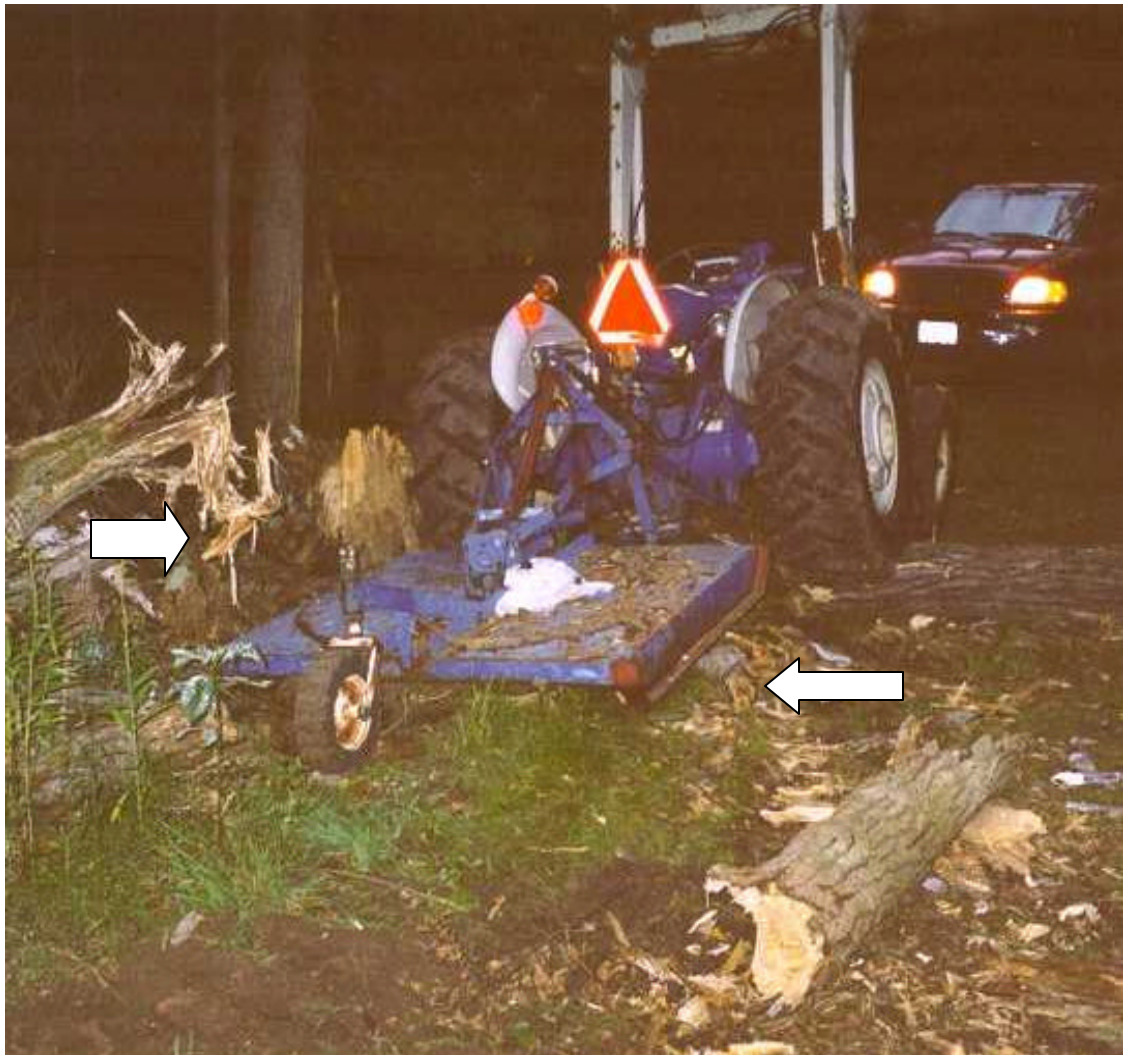
- The upper left arrow indicates the stump of the tree struck by the bucket.
- The bottom right arrow indicates the victim's approximate location.

**Recommendation #1: Farm tractor operators should follow tractor and bucket loader manufacturers' recommendations when using a bucket.**

Discussion: In this incident, the victim was using a tractor with a raised front bucket loader to knock down dead tree. The manufacturer does not recommend using the bucket to strike objects.

**Recommendation #2: Farm tractor operators should use only tractors that are equipped with falling object protective structures (FOPS) when working in a situation where objects might fall on the operator.**

Discussion: Some rollover protection structures (ROPS) frames can be equipped with overhead canopies to protect the operator from the weather and/or from falling objects. Canopies that protect against falling objects – called FOPS (falling object protective structures) – must be properly designed and certified for that purpose. Such canopies are recommended when using front-end loaders, working in the woods, or in other circumstances where falling objects may be a hazard. To be sure that a canopy is a FOPS and provides overhead protection from falling objects, purchasers of ROPS should check with the ROPS supplier. A ROPS frame or cab should never be modified by the farmer to install an overhead canopy that was not designed for that particular ROPS. The ROPS manufacturer should always be consulted about overhead protection. The tractor in this case was not equipped with ROPS, but a retrofit structure might

have been available from a dealer.
